APRIL 13, 2025

# Professional Home Inspection Report Like No Other

Comprehensive Property Assessment for 127 Chamberlain Street,  
Natick, Massachusetts

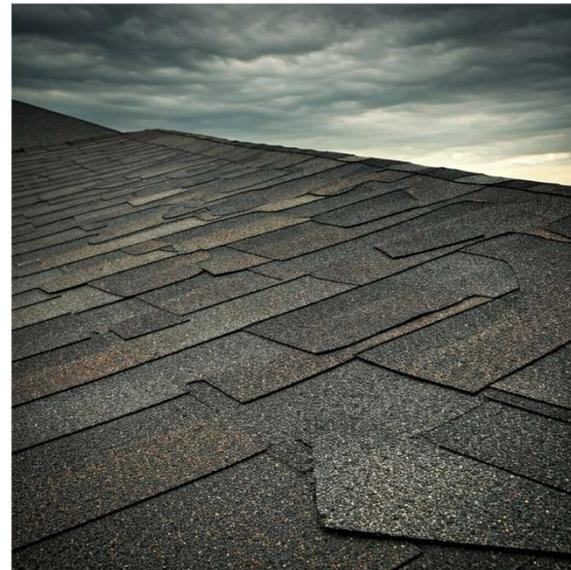
The roof inspection revealed multiple areas requiring attention. While roofs are designed to be water-resistant, no roof system is completely waterproof, and eventual leaking is inevitable without proper maintenance.

Your roof covering shows signs of aging and wear, with cracked shingles, damaged materials, and improper fastening observed in several locations. These conditions increase the likelihood of water intrusion during heavy weather events.

**Roof Materials:** Asphalt shingles and flat roof material were observed. The system appears to be at the end of its service life and may require replacement in the near future.

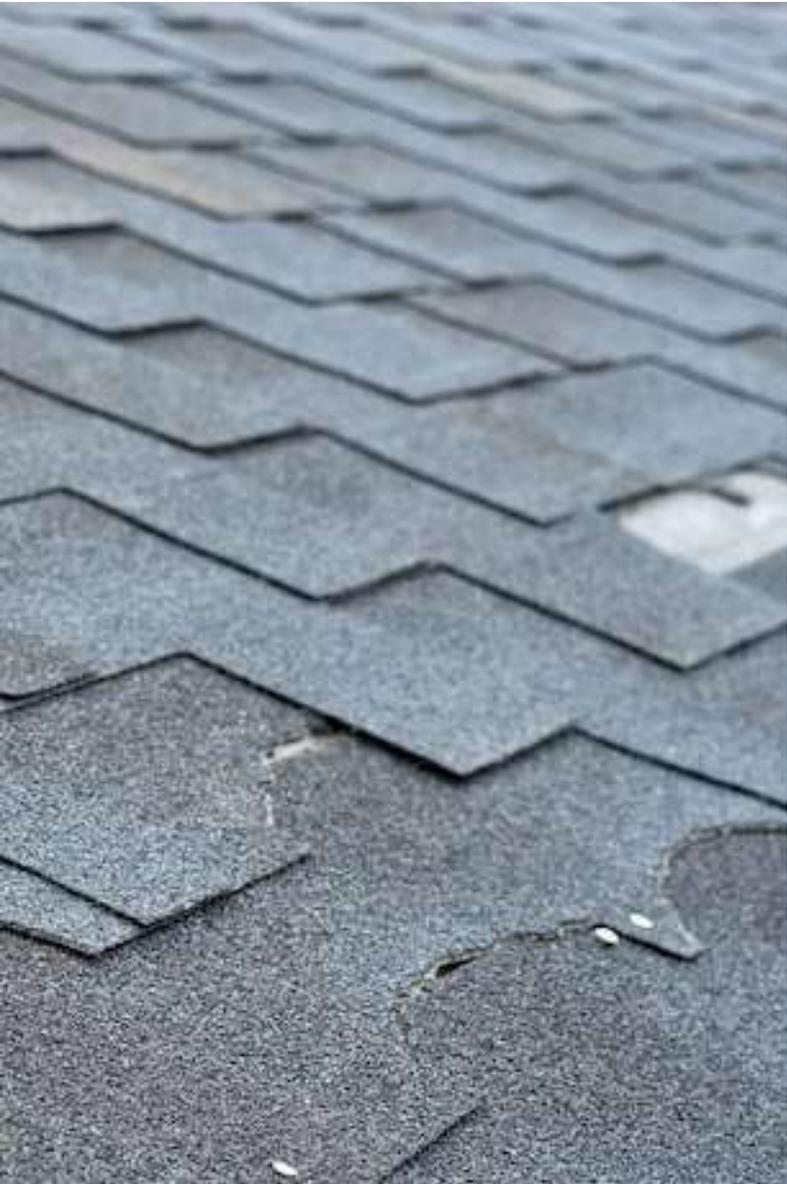
Multiple areas of cracked, splitting, and damaged roof-covering materials were observed. This represents a major defect prone to water leakage into the home structure.

Improper fastening of roof-covering materials was observed in multiple locations, creating vulnerability to wind damage and water penetration.

**Action Required:** Professional roofing contractor evaluation and repair recommended immediately.

**Action Required:** Qualified roofing professional should secure all loose materials.

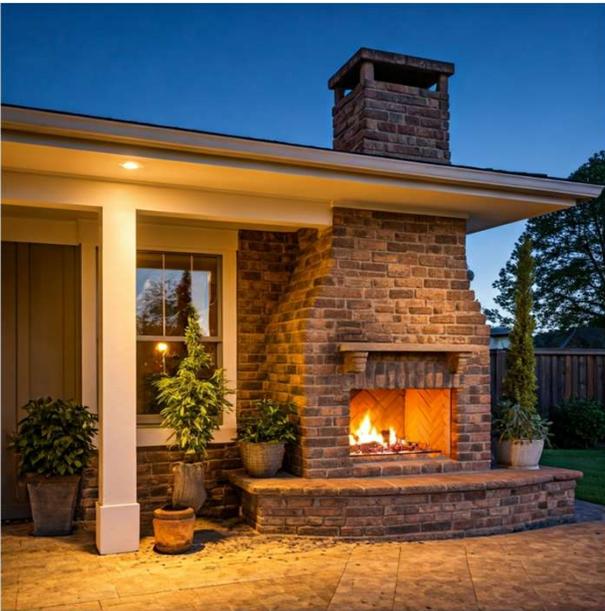
A masonry fireplace and chimney system was inspected during this evaluation. The inspection focused on readily accessible and visible portions according to standard practice guidelines.

Visible damage was observed to the fireplace interior chamber. This represents a potential safety hazard as compromised fireboxes can allow heat transfer to combustible materials or carbon monoxide intrusion into living spaces.

The fireplace damper door exhibited defects including creosote buildup and restricted movement. A properly functioning damper is essential for controlling airflow, preventing heat loss, and ensuring safe operation.

**Action Required:** Qualified fireplace contractor should evaluate and repair immediately before any further use.

**Action Required:** Professional chimney sweep should clean and repair the damper mechanism.

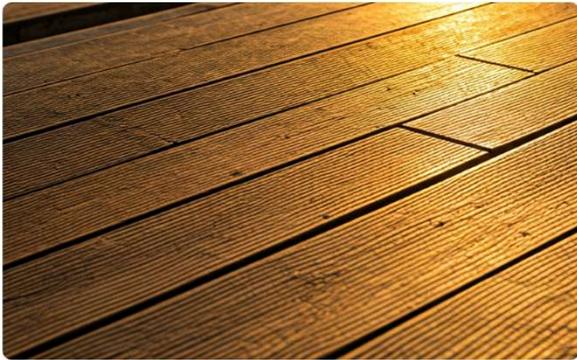
### Deck Deterioration

Significant deterioration was observed in deck components including surface boards, support posts, and connection hardware. Deteriorated deck structures pose safety hazards and can collapse under load.

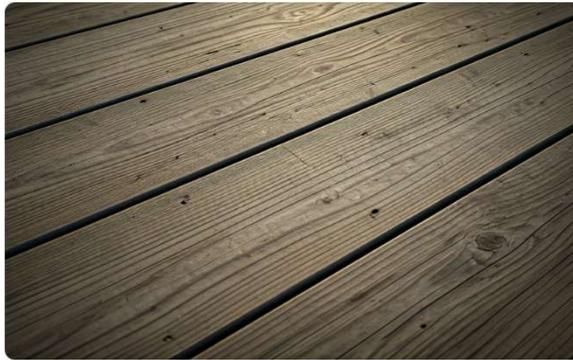
### Worn Surfaces

Deck surfaces showed extensive wear from weather exposure and foot traffic. Worn finishes allow moisture penetration, accelerating wood decay and creating splinter hazards.

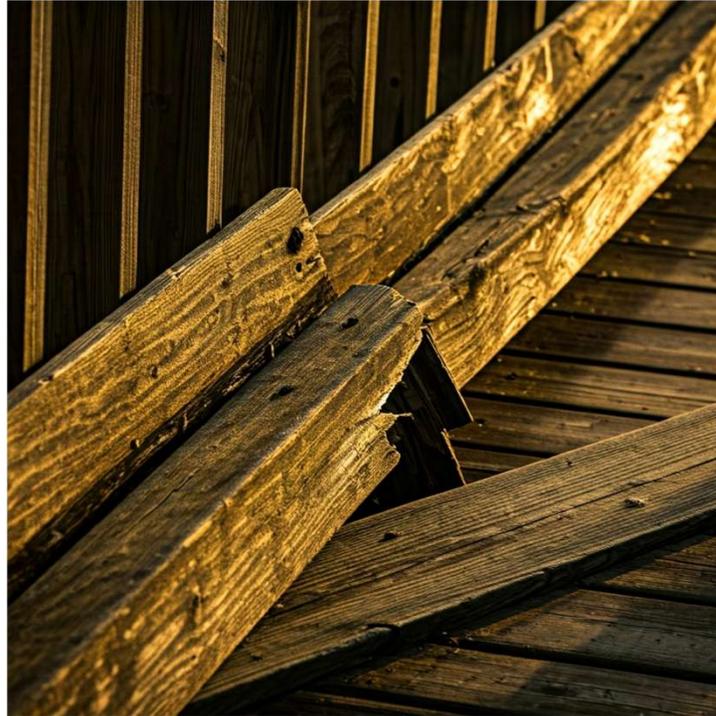
Loose railing components were observed at exterior stairs and elevated deck areas. This condition represents a serious safety hazard as railings must support 200 pounds of force in any direction.

Loose railings can completely fail when someone leans against them or grabs them for support, resulting in serious falls and injuries.

**Immediate Action Required:** Contact qualified handyman or contractor to secure all loose railing components before allowing anyone to use these areas. Consider temporary barriers until repairs are completed.

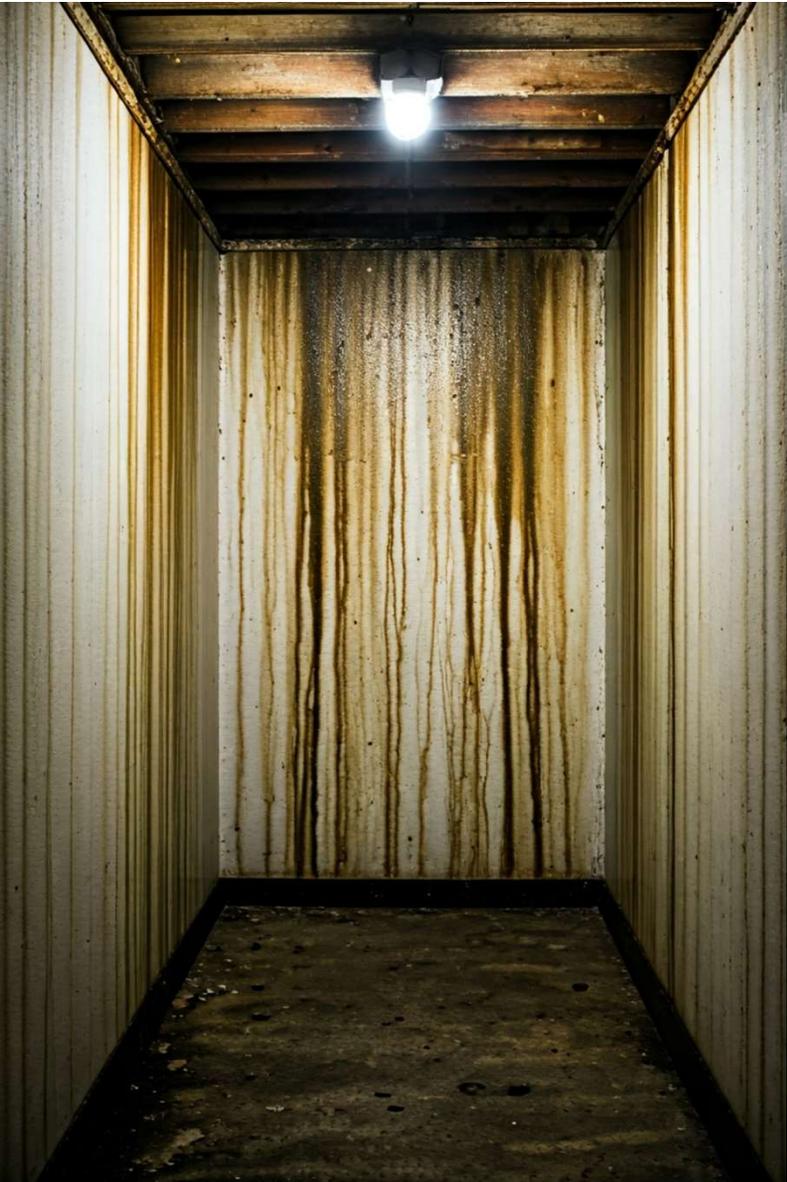
The foundation and structural systems provide the essential support for your entire home. This property features both a basement and crawlspace foundation constructed with masonry block and brick. Understanding the condition of these critical elements is vital for long-term home stability and value.

Structural inspections examined readily accessible floor joists, foundation walls, and support systems. Areas with restricted access due to personal storage or finished surfaces could not be fully evaluated.

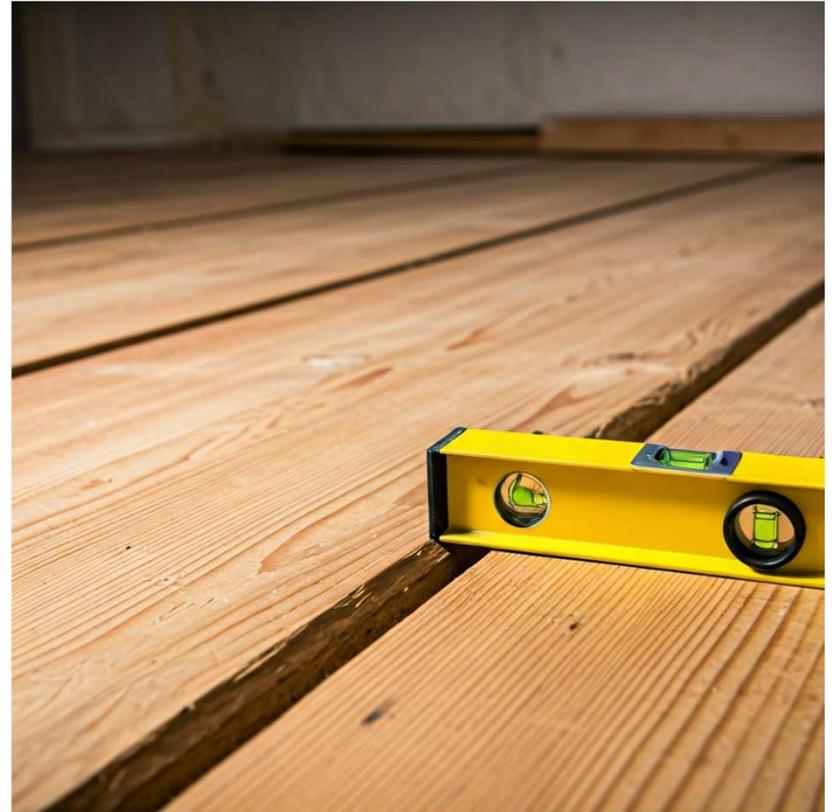
Significant floor leveling issues were observed in basement areas, indicating possible foundation movement or settlement. Unlevel floors can result from:

While some minor settlement is normal in aging homes, significant deviations warrant professional structural evaluation to determine cause and necessary corrections.

**Professional Assessment Needed:** Contact qualified general contractor or structural engineer to evaluate foundation movement and recommend appropriate repairs.

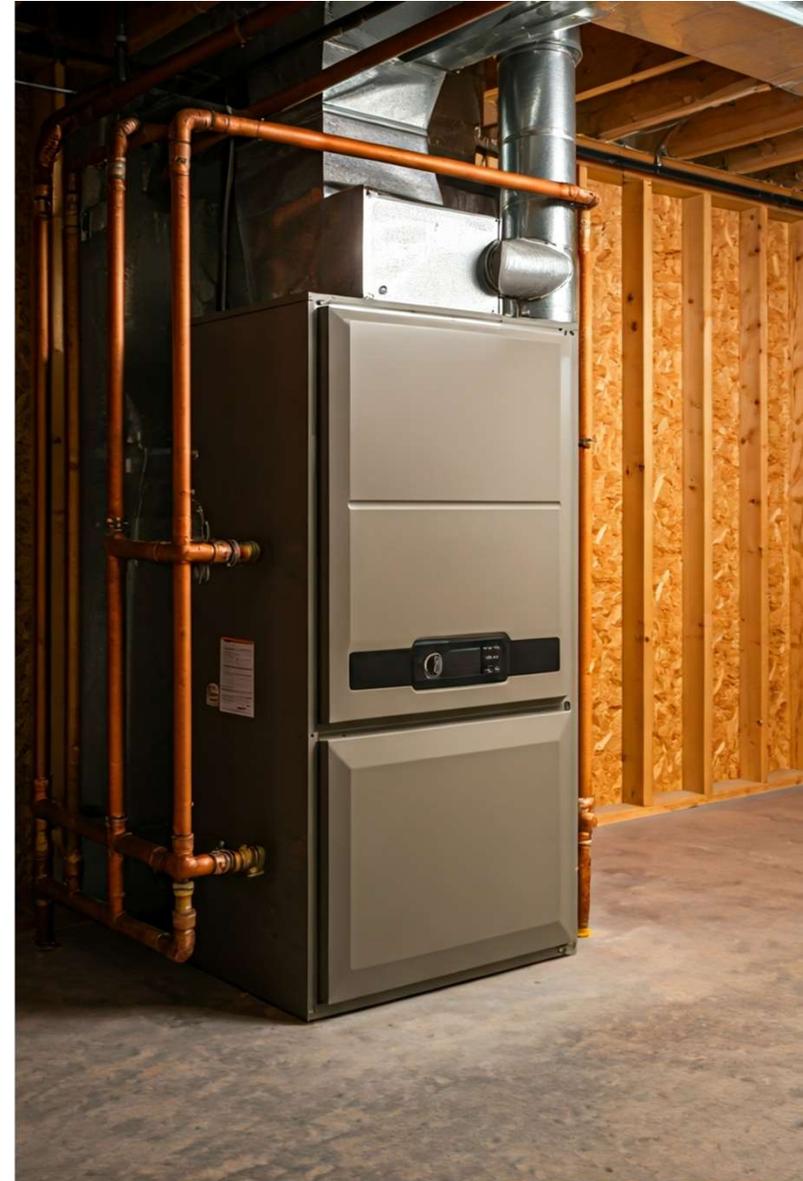
The home features a gas-fired warm-air heating system controlled by multiple thermostats. Regular professional maintenance of HVAC systems is essential for safe operation, energy efficiency, and system longevity.

The heating system was inspected using normal operating controls. Not all components could be fully evaluated due to access limitations and the visual nature of home inspections.

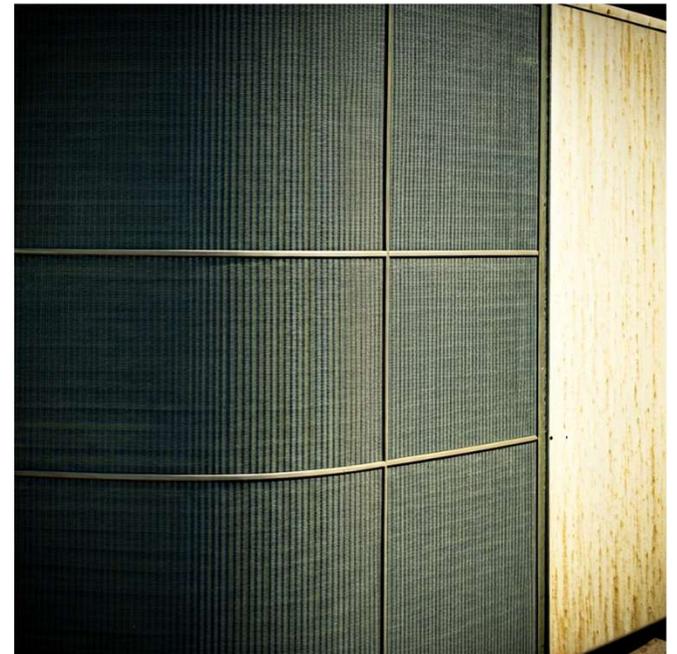
The air conditioning system's condensate discharge pipe requires extension. When cooling systems operate, they remove moisture from indoor air, producing condensate water that must be properly discharged away from the home.

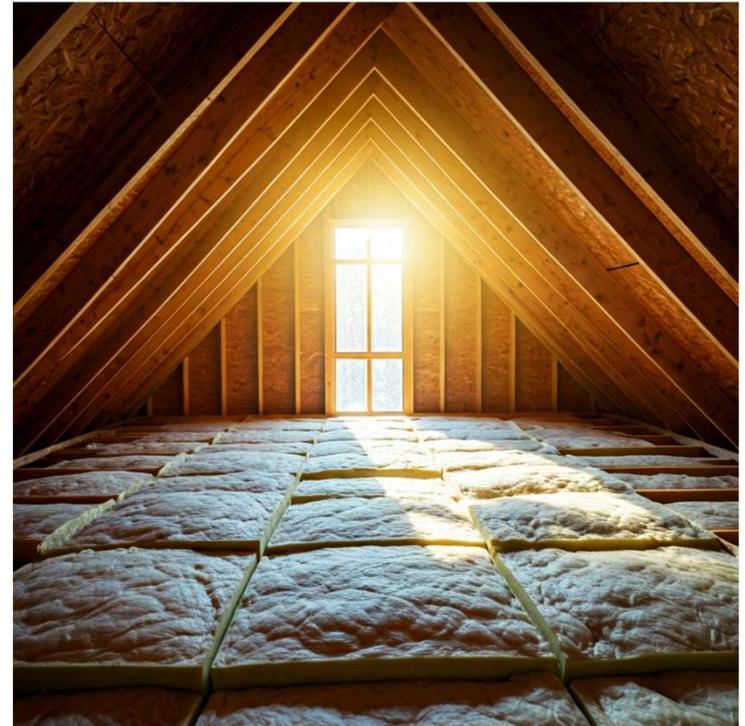
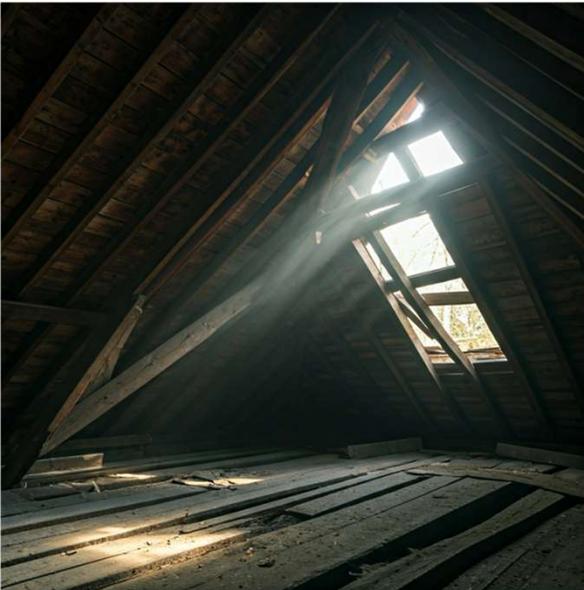
## Attic Structural Defect

### Major Structural Concern

A major structural defect was observed in the attic affecting roof support members. Bending and deflection of structural components from the attic to the roof structure indicates:

**Immediate Action Required:** Contact qualified carpenter or structural engineer to evaluate and design proper repairs. This condition could lead to progressive failure and potential roof collapse if not corrected.
